Seeing through the problem...

...wiring deterioration made visible

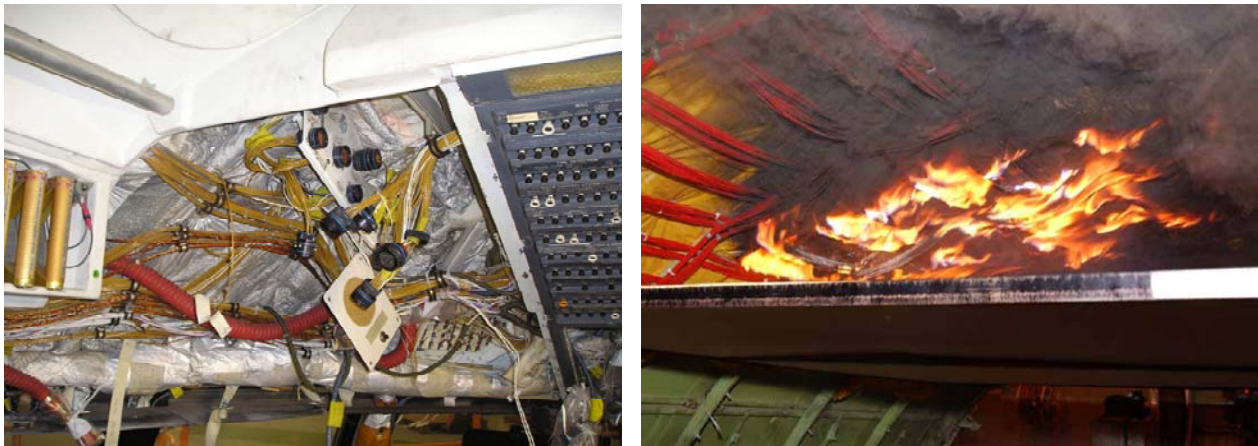
Figure 1 Wiring inside aircraft structures is critical

In today's military and commercial aircraft, many miles of wiring are subject to heat, cold, moisture and vibration, which can make them brittle and fragile. Consequently such cabling becomes susceptible to cracking and abrasion, and can short circuit. Degradation and failure of aircraft wiring insulation in particular results in the failure of safety critical systems or even the risk of fire due to arcing (Figure 1).

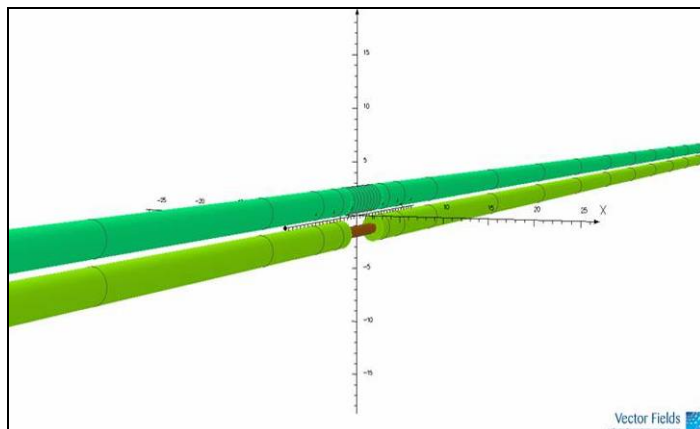
Figure 2 Computer model of a figure of eight power cable with 10 mm fault on one conductor insulation. This model was 10 meters long cable.

An Enhanced TDR technique has been developed at the London South Bank University (Faculty of Engineering, Science and Built Environment) which allows detection of insulation damage in electrical wires, and shield and braiding damage in coaxial and shielded twisted pair cables. The technique was developed for remote inspection of inaccessible wiring in aircraft, and can be applied to wires in excess of 10 meters of length. The TDR method is not new and has been in use for many years. It is however very attractive, since access to only one end of the wire system is required. The novelty of the new technique is in the selective use of the method, and in the arrangement and injection of successive pulses into the wire under test, which puts the new test procedure into a completely new perspective. Computer models of the technique were initially simulated using Vector Field software from Cobham Technical Services, before test procedures were created. Figures 2 and 3 show initial 3D models of insulation fault created in an 8 Amp figure of eight power cable, and an unshielded twisted pair cable respectively. Figures 4 and 5 show actual 10 mm damage created on the shield and insulation on one side of a coaxial cable (core conductor undamaged), and the corresponding fault detection using the ETDR technique respectively.

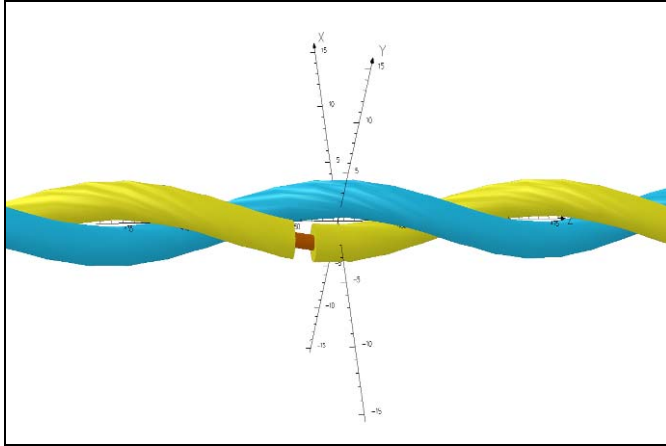
Figure 3 Computer model of an unshielded twisted pair cable with a 2.0 mm fault on one conductor insulation. This model was a simulation of a half a meter long cable.

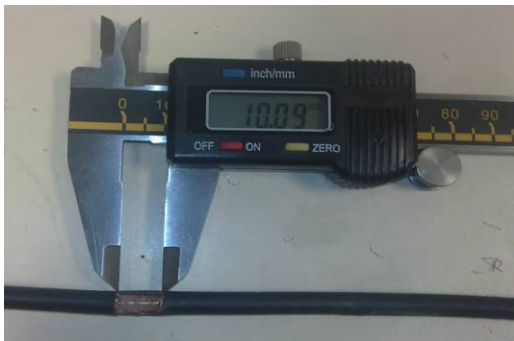
Figure 4 Coaxial cable with a 10 mm damage created on the shield and insulation on one side with the core conductor undamaged. The fault was created near the middle of a 6 meter long cable.

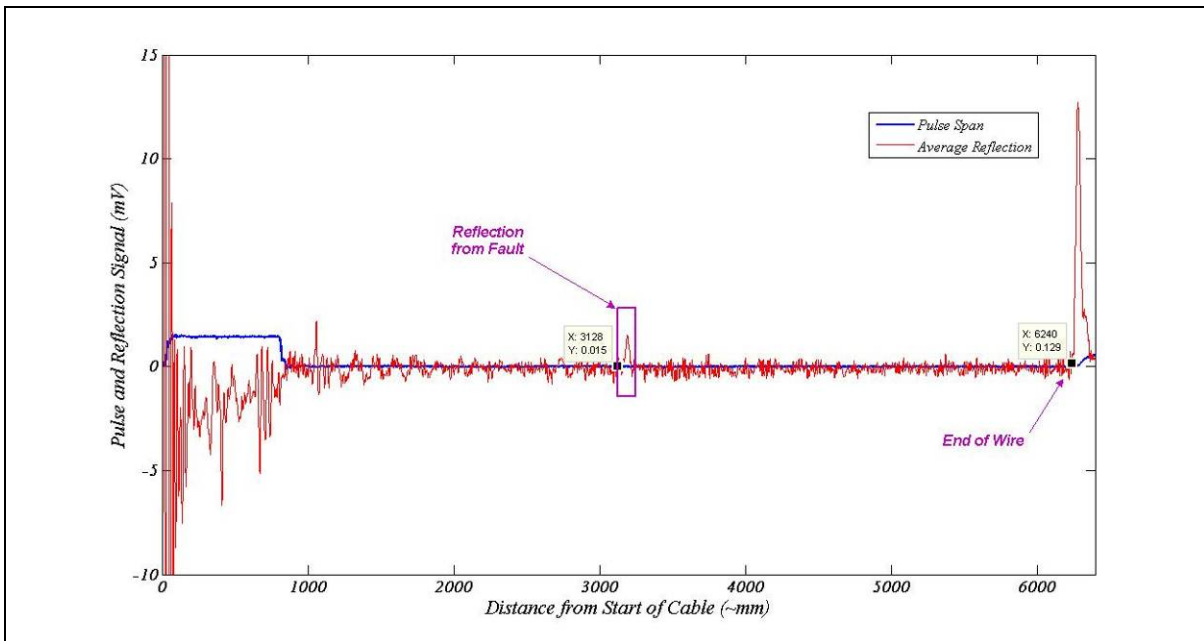
Figure 5 Shield fault detected for a 10 mm damage shown in fig 3, using the ETDR technique.

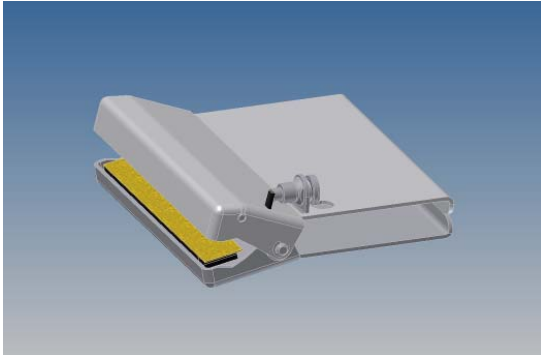
Figure 7 Prototype of the transducer clamp

Trials with prototype transducers in a simple clamp have been very successful (Figure 7). Test ranges of 6m have been achieved (Figure 8). A wide range of wire defects including abrasions, burns and cracks in single and multi-strand wires have been detected on long distances.

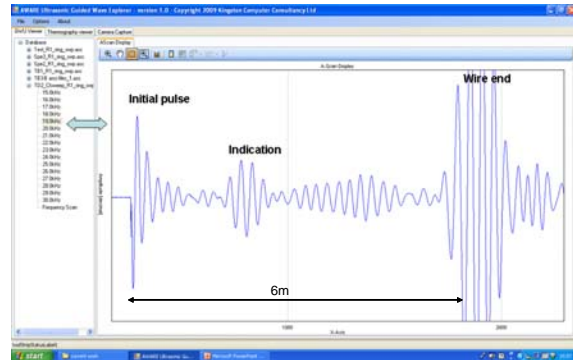
Figure 8 LRUT A-scan

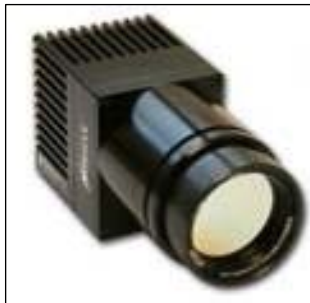
The IR thermal imaging system developed at TWI uses a system comprising an IR camera (opposite picture) and a heating source.

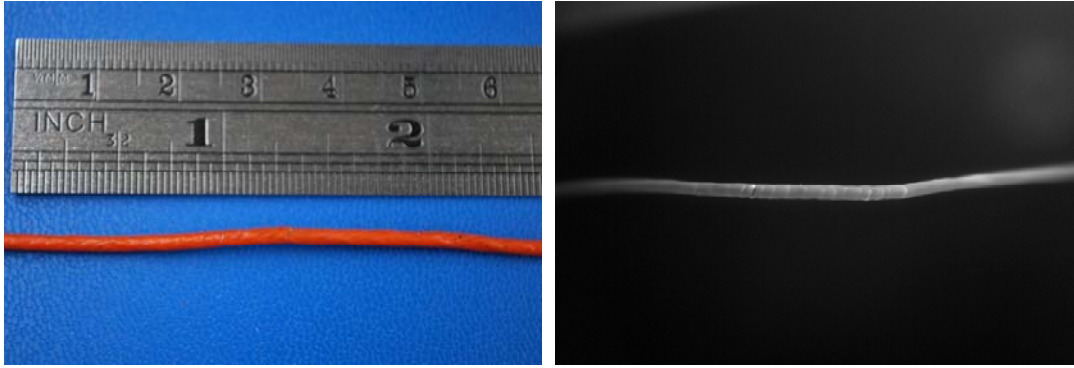
Figure 9 Wire inspected visually (left) and with the IR thermal camera (right)

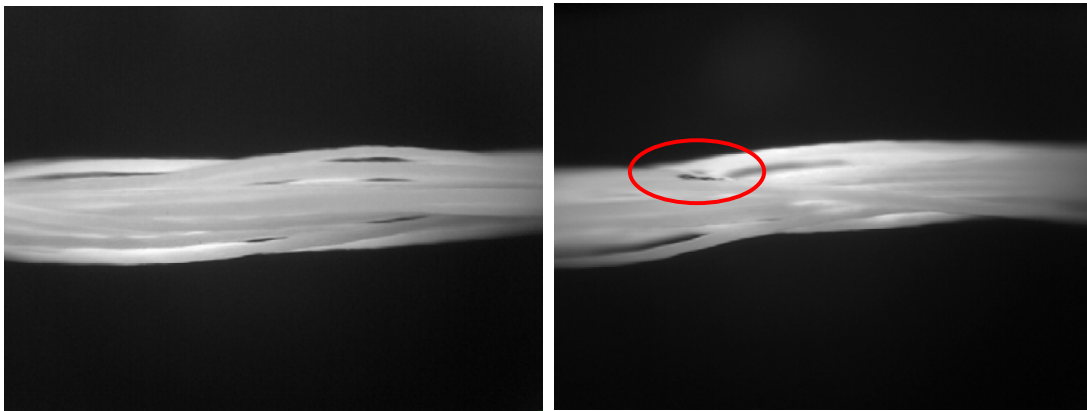
Figure 10 IR thermal imaging images. Non defective area (left) – area containing a defective wire (right)

If the insulation is defective, the defective area will have a different heating/cooling rate from the rest of the wire. So the defect effectively identifies itself. The visual image given by the IR camera is then sent to a PC and is analysed automatically and in real time using dedicated software, developed specifically for the AWARE project. The experimental work shows that the IR thermal imaging system used with an appropriate heating source can detect defects that are visually very difficult to see and in some cases that can not be seen visually (Figures 9 and 10). Ultimately it may be possible to distinguish wiring degradation by comparing the heating and cooling times of new and old wires.

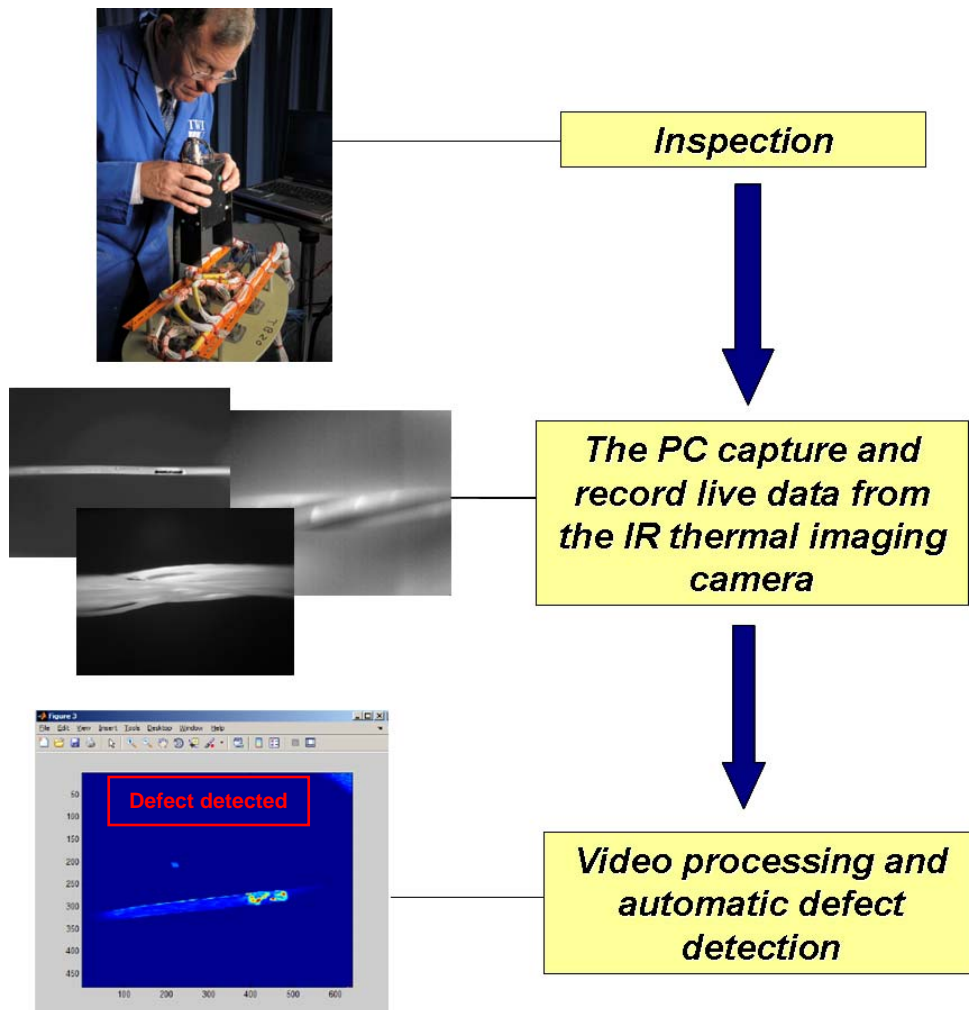
Figure 12 Inspection of defective wires using the thermal imaging system comprising the IR camera and the heating source. After recording the image given by the IR thermal camera, the AWARE integrated software allows automatic detection of defects on wiring.

The finality of the system developed is to enhance detection of damages in aircraft wiring using IR thermal imaging and a dedicated custom built software (Figure 11).
