NOVEL TECHNOLOGIES FOR IMPROVING WIRE SYSTEM INTEGRITY

George A. Slenski, Air Force Research Laboratory, Materials and Manufacturing Directorate,
AFRL/MLSA, Wright-Patterson AFB, OH 45433-7718

Michael F. Walz, Aging Aircraft Electrical Systems, Federal Aviation Administration,
William J. Hughes Tech. Center, AAR-480, Atlantic City Int'l Airport, NJ, 08405

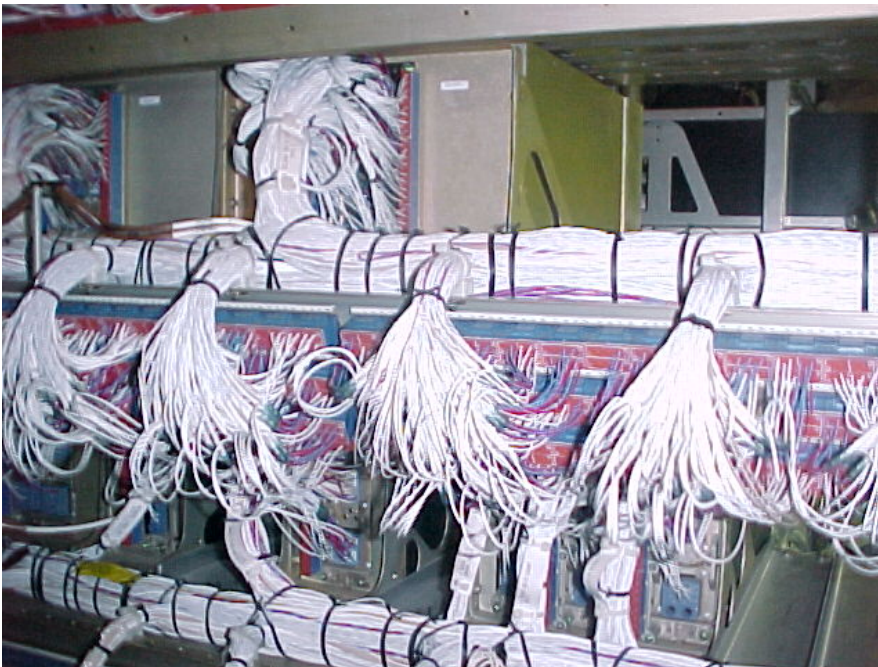
Figure 1. Typical wiring from the back of the electronics rack of an in-service transport aircraft.

New aircraft continue to increase in wire system complexity and volume as traditionally mechanical systems such as flight controls and flight surface control actuators are converted to all electric systems. A modern transport aircraft contains over 200 miles of wire most of which is typically 20 gauge or smaller single conductor wire. An example of wire systems used on commercial aircraft is shown in Figure 1.

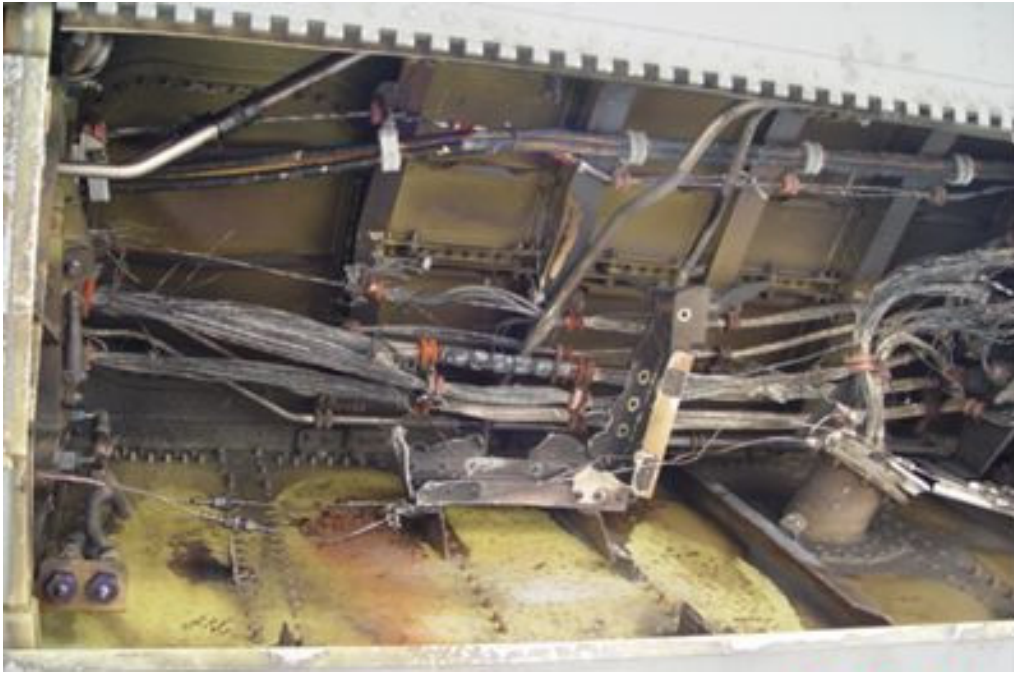
Figure 2. In-flight electrical/hydraulic fire in an aircraft wing area. The fire caused extensive wiring damage, a fire extinguisher system to rupture, and damage to the wing structure.

Fortunately the aircrew was able to make a successful landing and damage was confined to the internal wing components and structure (Figure 2).

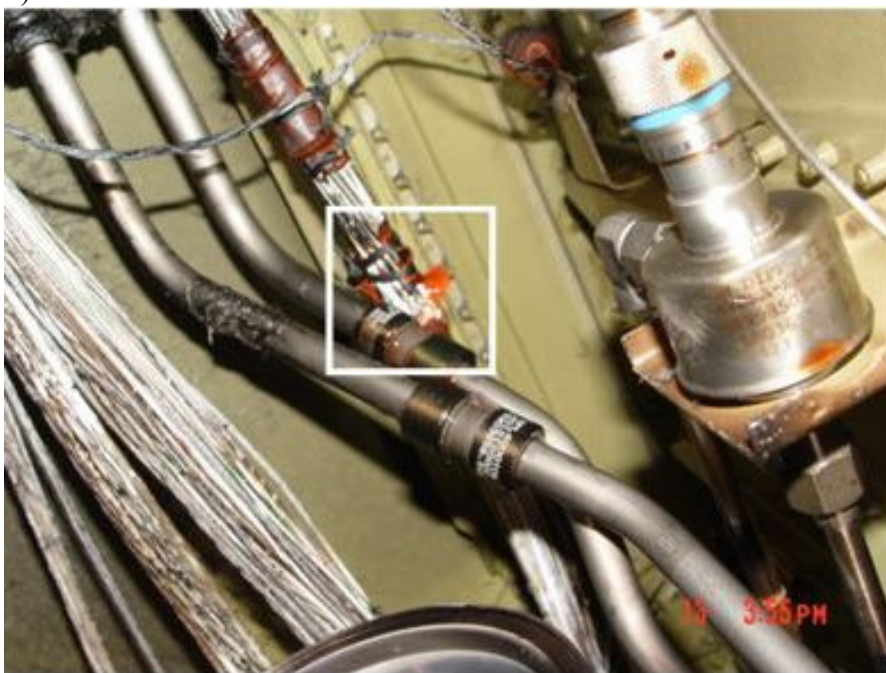
Figure 3. Failure initiation site is shown in the white box. Note that the wire bundle is lying on the hydraulic line. Red anti-chafe tape was used to protect the wiring.

A wire bundle containing 115 VAC power and various aircraft functions chafed to a high pressure titanium hydraulic line in a location that is rarely accessed by maintenance personnel (Figure 3).

The wire bundle was laying on the hydraulic line and over time, the hydraulic line couple chafed through the wire insulation. Exposed conductors arced to the titanium hydraulic line. Arcing was sufficient to breach the titanium tube, releasing high pressure hydraulic fluid that was

subsequently ignited by the continued arcing. Most damage to the remaining wiring and loss of multiple systems was due to external heating by a flame front fueled by the spraying hydraulic fluid. Temperatures in excess of 600°C were reached, as evidenced by the degradation of the Kapton[®] wire insulation. Arc tracking was minimized by the use of MIL-W-22759/87 wire insulation, a composite construction of Kapton[®] and Teflon[®] layers. The Teflon[®] layer interrupted the conductive path created by charred Kapton[®] film. The hydraulic fire also caused a fire suppression line to rupture, damaging

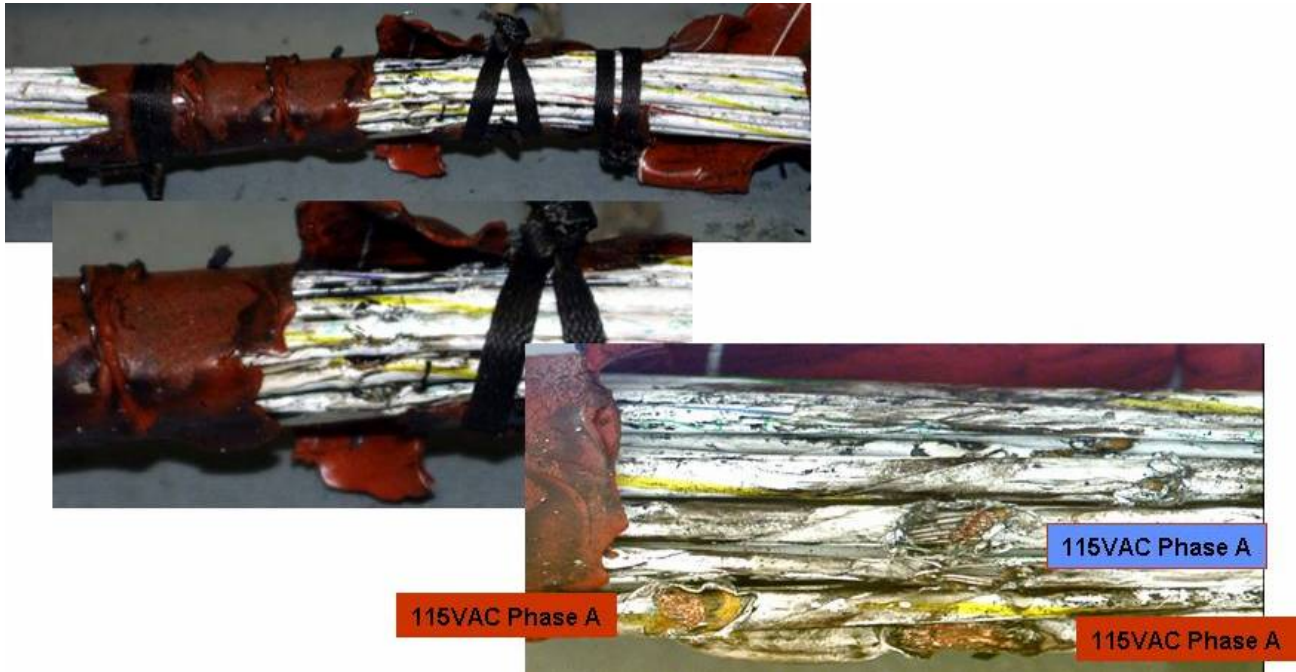
Figure 4. Close-up of wire bundle and wires that arced to the hydraulic line. The insulation was M22759/87, a composite wire construction that has excellent arc track resistance properties.

part of the wing structure. Only three 115 VAC three phase 12 gage wires actually arced to the hydraulic line. The 15 ampere thermal circuit breakers protecting the wires tripped at some point during the failure. A close-up of the wires that arced to the hydraulic line is shown in Figure 4.

Note the exposed conductors that resulted from chafing to the hydraulic line couple and melted copper conductors that arced to the hydraulic line. An example of a chafed wire that did not arc and a wire that was rubbed several times across the hydraulic line couple is shown in Figure 5.

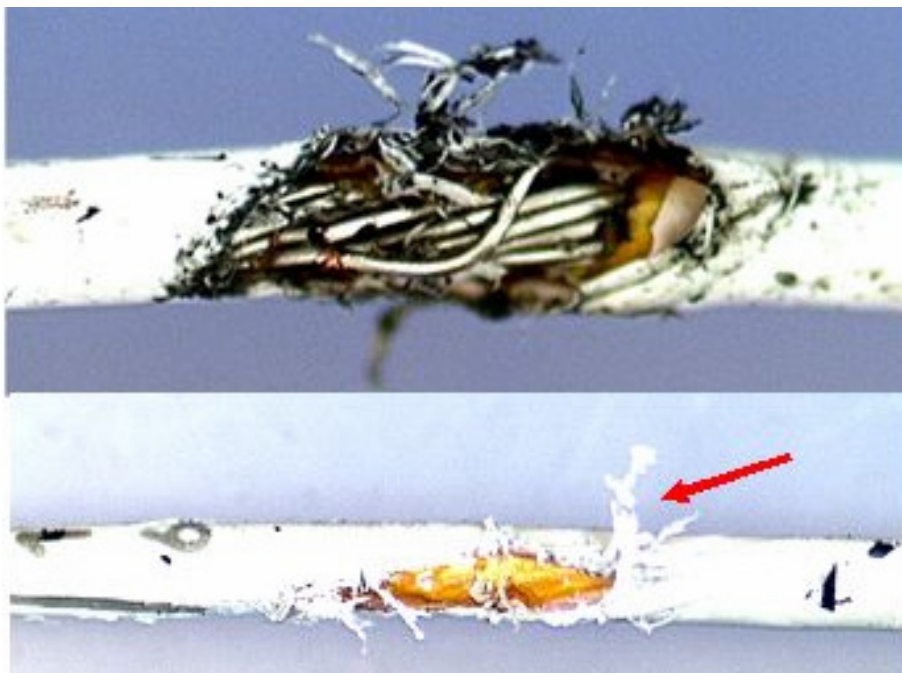
Figure 5. Top photo shows wire from incident which exhibits chafing and exposed conductor damage. An undamaged wire from the incident bundle was manually chafed against the coupling of the 'good' hydraulic line. The bottom photo shows abrasion damage created by lab personnel for comparison.

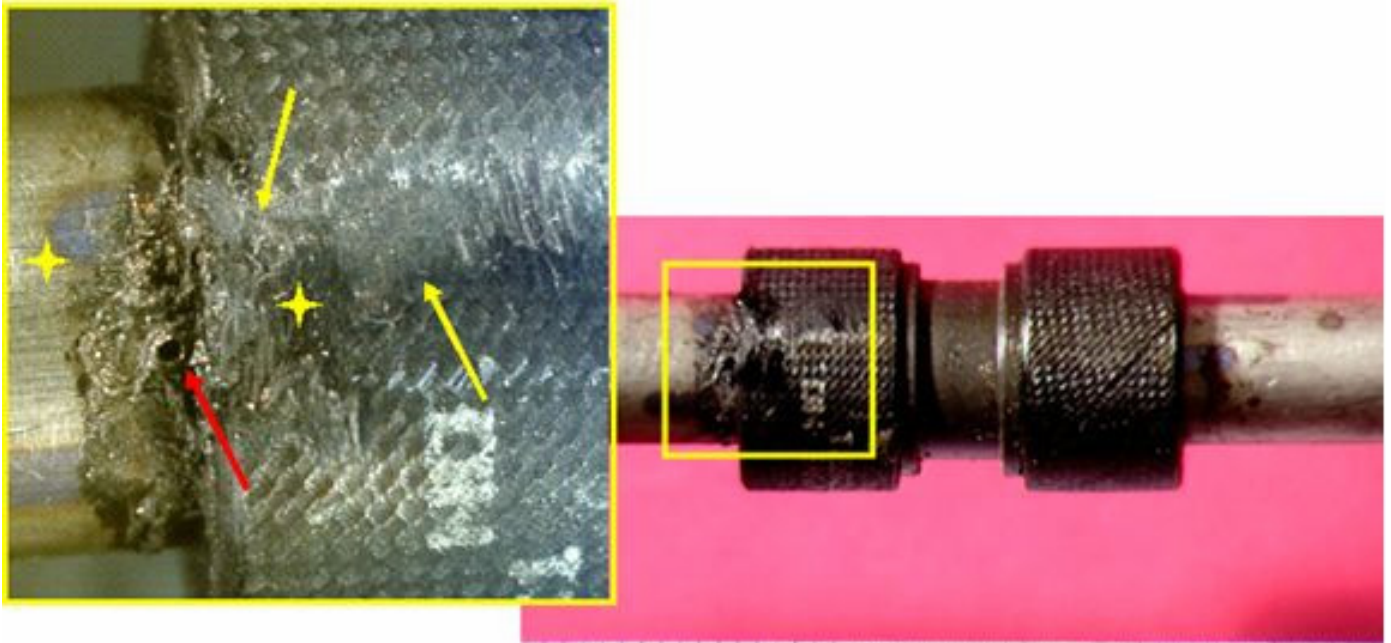
Figure 6. Arc initiation site on hydraulic line is shown in the yellow box. Red arrow in close-up photo highlights pinhole location; yellow arrows highlight chafing of coupling composite. Note the broken composite fibers near the tube-couple interface. A conductive path was measured between the yellow stars.

The arc initiation site on the hydraulic line is shown in Figure 6. A close-up of the damage site (Figure 6) shows the pinhole location in the hydraulic line and chafe areas on the composite couple. Note the broken composite fibers near the tube-couple interface. Scratching through a thin layer on the composite couple material revealed it was conductive.

The hydraulic line pinhole location exhibited molten titanium on the surface with rich areas of copper from the arced wires (see Figures 6 and 7).

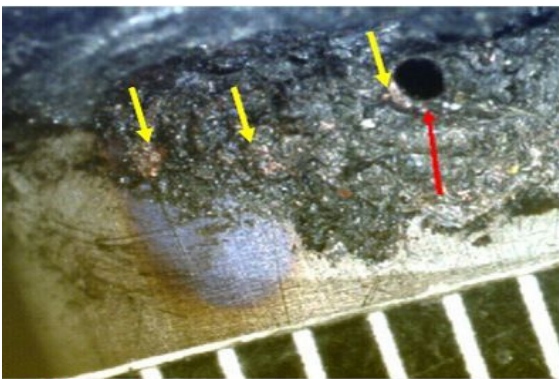
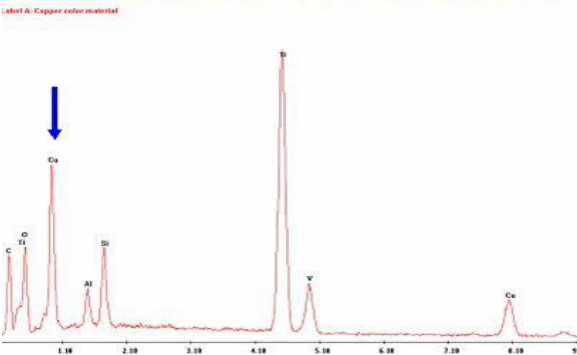
Figure 7. High magnification of hydraulic line pinhole location with surrounding molten material (red arrow). Note copper-colored areas (yellow arrows) that were verified as being copper rich using a scanning electron microscope with energy dispersive analysis (lower image). These characteristics confirm arcing occurred between several wires (see Figure 4) and the hydraulic line.

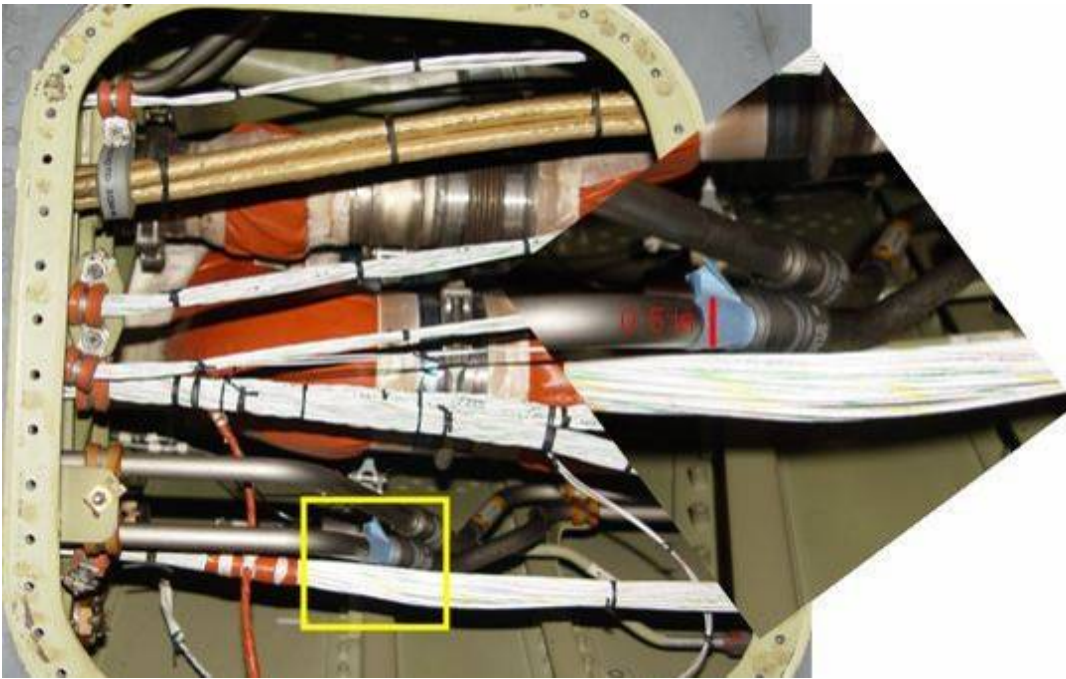
Figure 8. Inspection of the incident area on another aircraft shows there is inadequate separation between the incident wire bundle and hydraulic line (yellow box).

Inspection of the incident hydraulic line on operational aircraft revealed there was inadequate separation between the wiring and hydraulic line on several vehicles (Figure 8).

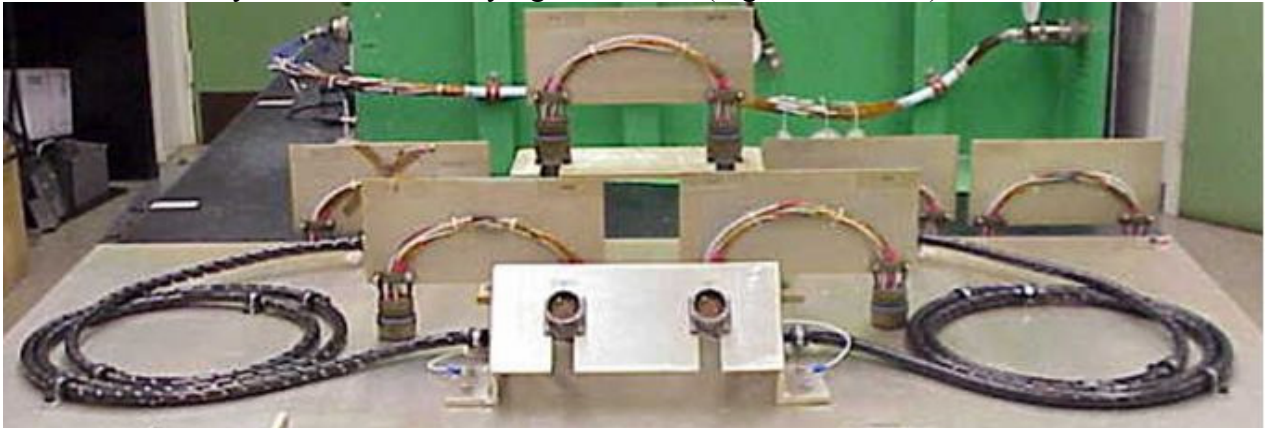
Figure 9. Test bed for evaluating wiring diagnostic systems. The system was fabricated with parts used on a military fighter aircraft and has removable test patches in the center that introduce wiring faults.

In Air Force evaluations we have defined an electrical short as less than 10 ohms @ ≥ 100 milliamps and an open as greater than 1×10^6 ohms @ 100 volts DC. A test bed developed at the Air Force Reach Laboratory is shown in Figure 8. This test bed allows connector or pin to pin testing of various wire configurations with removable test patches using wire types, interconnections, and electrical faults commonly found on a military fighter aircraft (Figures 9 and 10).

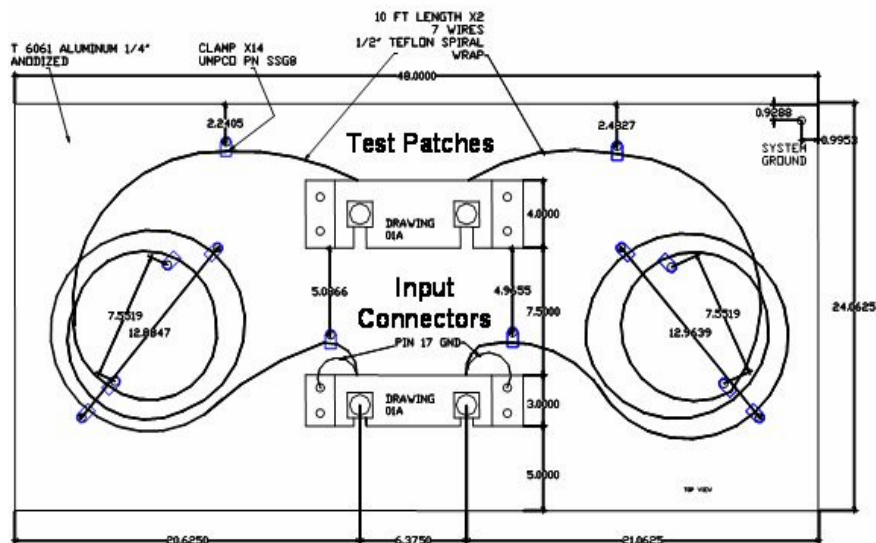
Figure 10. Engineering drawing of the test bed showing construction details and wire bundle lengths. The distance between input connectors is 21 feet or 252 inches. Distance from the connector to test patch faults is approximately 10.5 feet or 126 inches.

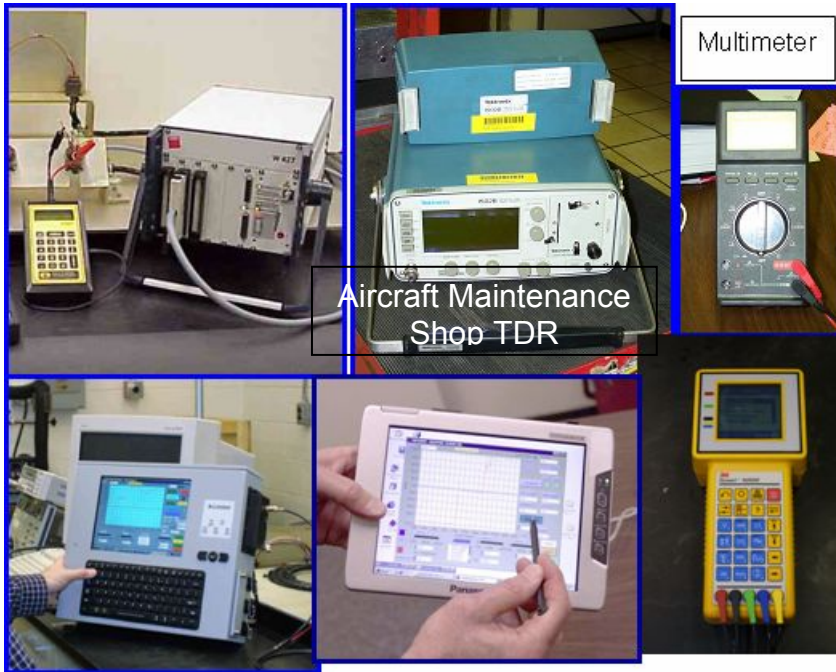
Examples of the evaluated equipment are given in Figure 13. *Figure 13. Wire diagnostic equipment evaluated. Aircraft maintenance shops currently use a multimeter and a manual TDR (upper center) to locate wiring faults.*

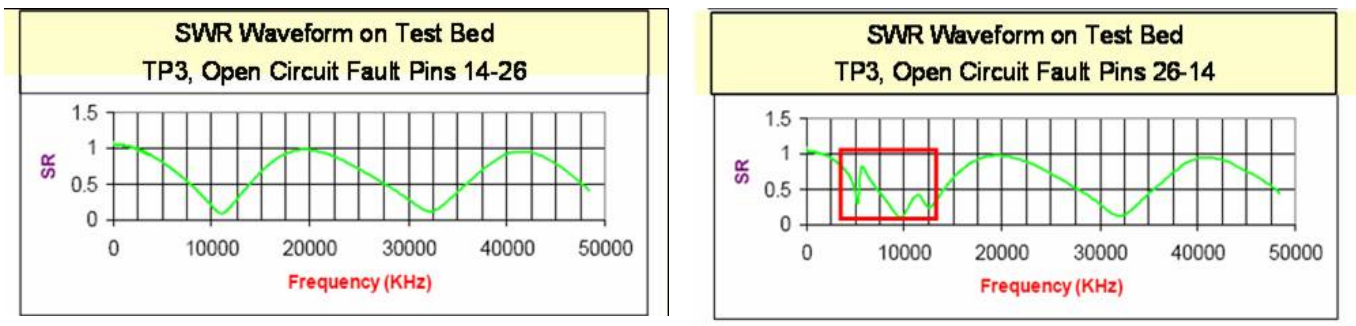
Figure 14. Display on the left shows a SWR waveform of a Triax shielded wire. The system detected an open fault within 3 inches for the actual fault location. Display on the right is a SWR waveform of the same triax shielded wire with the input pins reversed. In this case the system detected an open fault within 245 inches of

the actual fault. The error was due to waveform distortion in bottom waveform (red box), which is a strong indication that the measurement is suspect.

length of wire using the test bed (approximately 252 inches). After calibration, a test patch with a short or open was placed in the test bed. Faults were approximately 126 inches from the input connector. Analysis of the test results show most of the evaluated equipment could correctly identify an electrical short or open and give an approximate distance to the fault. As a reference, distances to fault readings were made with a TDR from an aircraft avionics maintenance shop (see Figures 12 and 13). This is the authorized equipment for locating an electrical fault in an aircraft wire system. Only a limited number of maintenance personnel have been trained to use this equipment. Equipment under this evaluation is automated and requires far less training than the manual TDR system. Most diagnostic systems were capable of consistently measuring a short or open in an unshielded twisted pair wire within 12 inches. Faults that were associated with an electrical ground (shielded twisted pair in Figure 12) did produce larger errors than 12 inches. Fault distance measurements to single wires shorted or open (single wire in Figure 12) varied considerably between evaluated equipment. This was expected for equipment that uses waveform reflections (vendors A-F) since the measurements are being made on wires with uncontrolled impedance. Of particular note was equipment that could display a waveform. An experienced user could determine if a reading had a high confidence level based on observing where the fault was placed on the displayed waveform (see Figures 14 and 15).

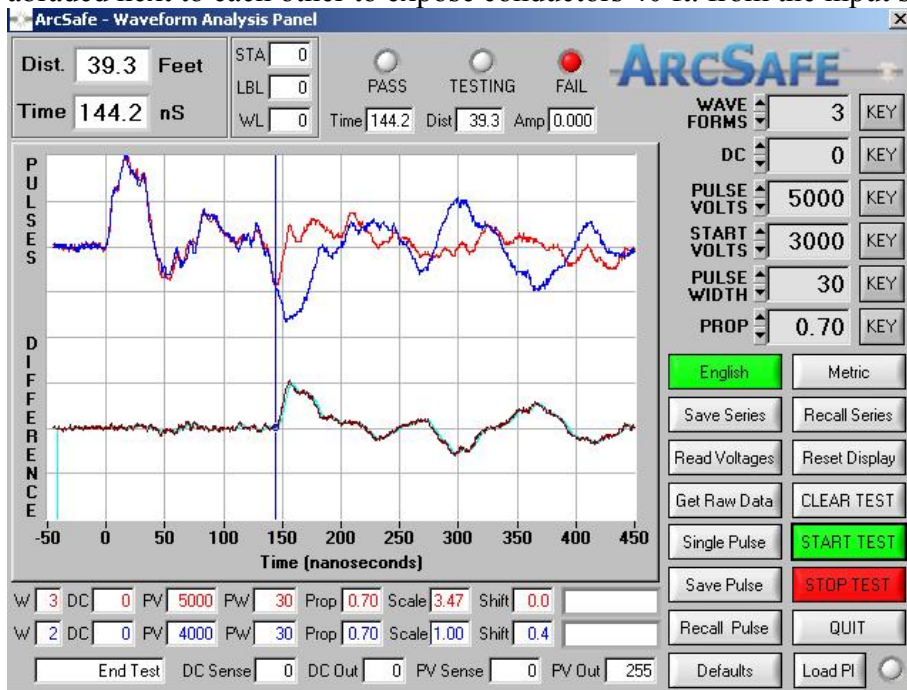
Figure 16. Screen output of system that imposes a high voltage, yet low energy pulse of wires to create a spark gap. In this case of fault was detected as 39.3 feet from the source. The actual fault was 40 feet from the input source.

An output screen from a prototype system is shown in Figure 16. Two single wires were abraded next to each other to expose conductors 40 ft. from the input source.

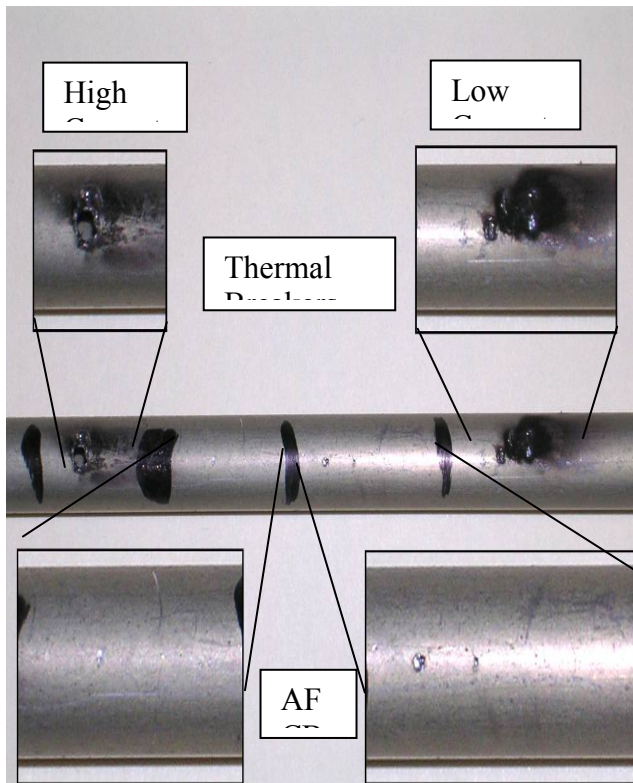
Figure 17. Examples of three phase 115 VAC arcing to a hydraulic line. AFCB devices and current limited thermal breakers effectively protected the aluminum hydraulic line.

In a recent study conducted at the FAA's Arc Fault Evaluation Lab (AFEL) tests were conducted to evaluate arc mitigation techniques (Ref7). One test simulated the electrical/hydraulic fire described earlier in this paper as shown in Figure 17 below.

This ongoing study showed the benefits of arc fault circuit breakers, wire insulation materials and fault current reduction on reducing damage from wires arcing to transport aircraft hydraulic line. The main purpose for the FAA study is to establish a guideline for the separation and segregation of critical fly-by-wire circuits.

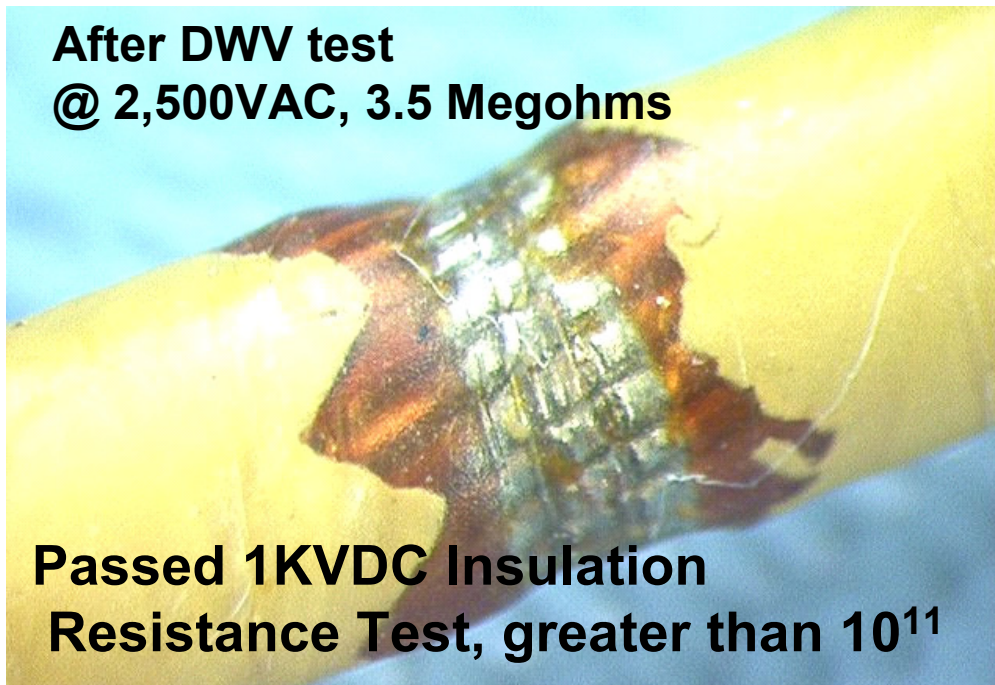
Figure 18. M81381 wire repaired with a meltable polyimide which passed insulation resistance and Dielectric Withstand Voltage(DWV) testing after immersion in a conductive solution.

Preliminary testing has demonstrated the concept and the first application may be a wire repair kit for existing wire constructions. A meltable polyimide based polymer that bonds to existing M81381 wire insulation is shown in Figure. 18.

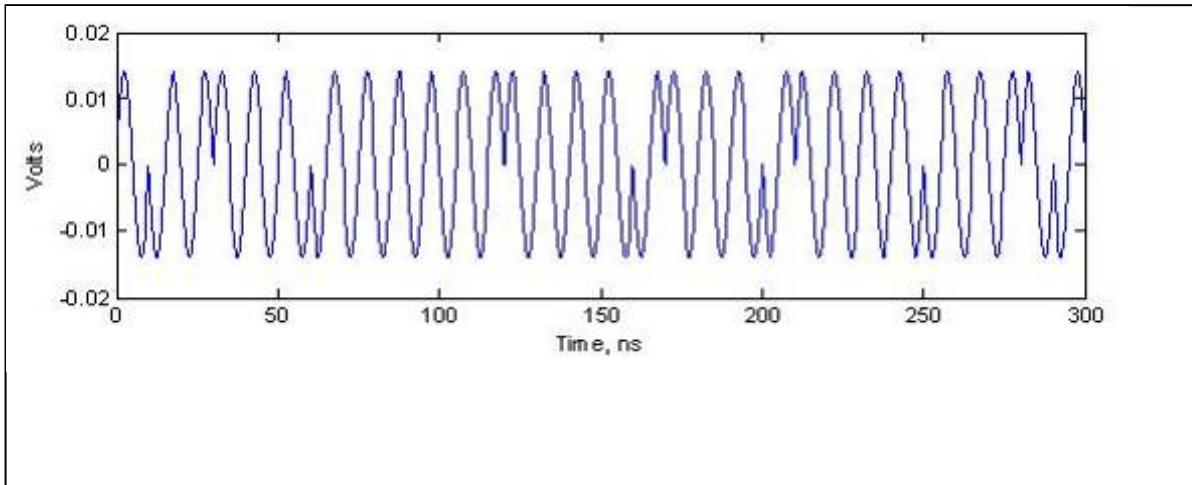
Figure 19: Typical PN code appears random to the aircraft but is a well-defined pattern as small as 10 millivolts.

A low level Pseudo-Noise (PN) code is sent down the wire and it is reflected when an open, short, or large impedance change is encountered. The PN code is a set of 1's and 0's that appears random but is actually a defined pattern well below the allowed noise margin of most systems. This is expected to prevent interference with the aircraft electrical system (Figure 19).

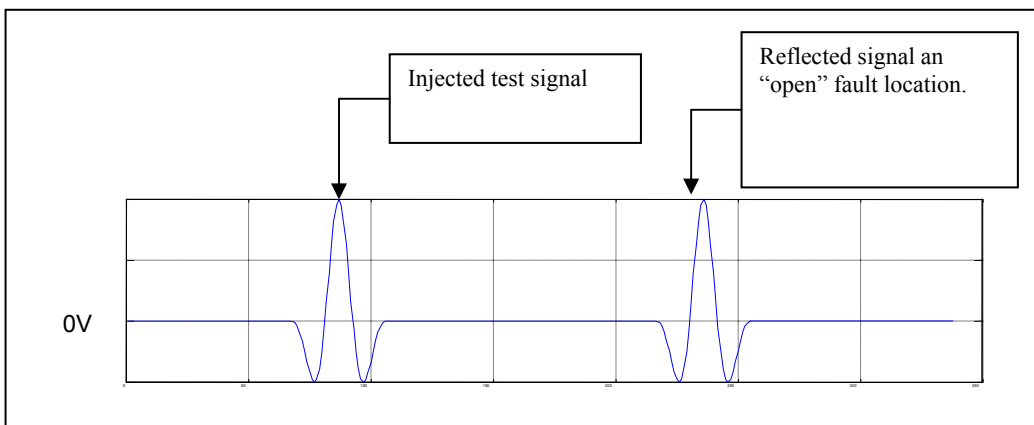
Figure 20: Ideal SSTDR correlation signal showing the reflection at the start of the board (left) and end of the line (right).

After the PN code signal has been sent, the reflections are analyzed. When the reflections have been processed, a waveform similar to that shown in Figure 20 is presented for further analysis and fault location calculations.

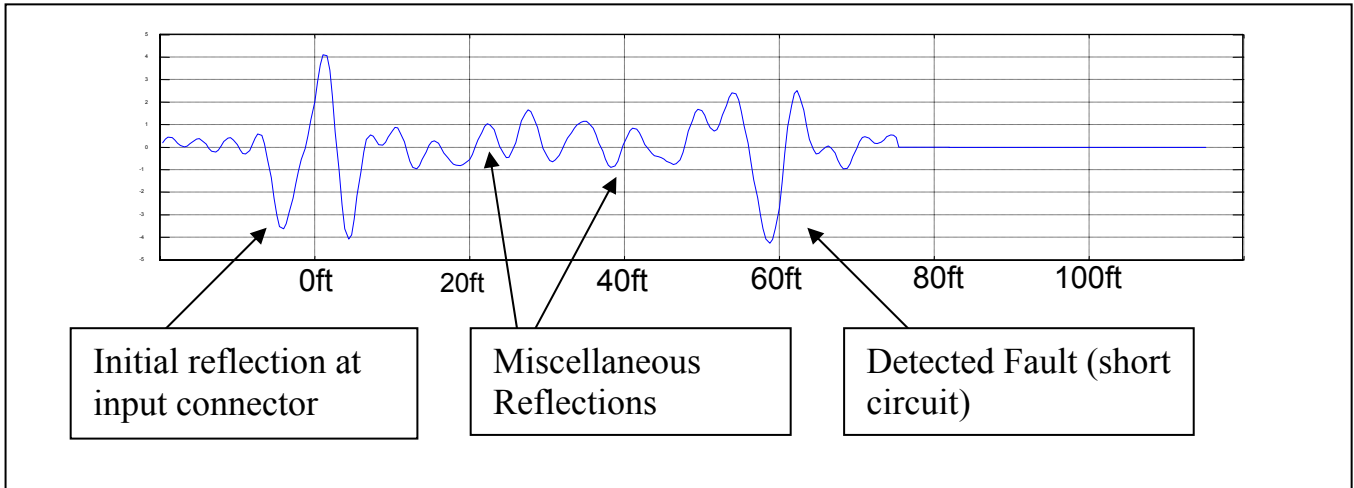
Figure 21: Measured SSTDR waveform for a short circuit approximately 60 feet from the start of the wire

An example of an SSTDR signal operating on a wire system with a “short” fault is shown in Figure 21. There are three parts to the waveform: the test signal, miscellaneous reflections, and the

fault. The large pulse on the left is the test signal being sent by the monitoring unit. Moving right on Figure 21 is a series of ripples representing reflected signals that will be filtered out in normal use. The next part of the waveform is the fault information; it appears to be upside down from the test signal, indicating there is a short on the wire being tested. The fault was detected approximately 60 feet from the monitoring system.

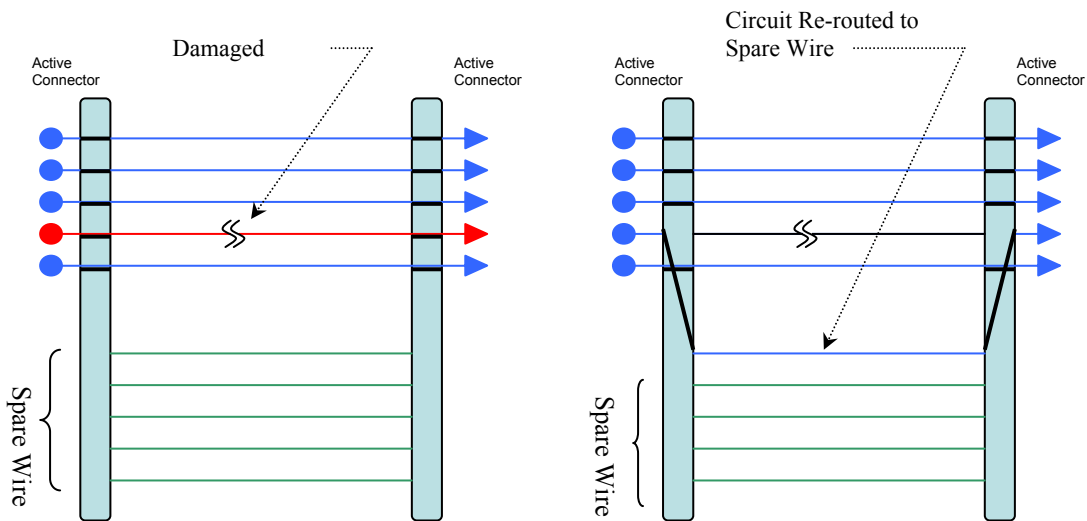
Figure 22. Self configuring wire system using an active connector for switching.

Aerospace wire systems that are self-healing and reconfigurable are being developed by NASA, as part of next generation wiring materials for the new manned space exploration initiative. This system would use an IHMS connected to an active matrix that would switch wire paths based on a failure condition or a change in mission profile (Ref 15). These systems would detect a circuit anomaly and allow active circuit switching to an alternate path. The active switching matrix would consist of a reconfigurable connector and Microelectronic Machine (MEMs) switches. A concept is shown in Figure 22. Once this system is developed, wire systems could be embedded in composite structure using conductive polymers. This would protect the wires for damage and reduce the overall weight and volume of the wire system.
