CF-18 Wire Harness Integrity Program

9th Joint FAA/DoD/NASA
Conference on Aging Aircraft
6-9 March 2006

*Lt Michael Clement, DAEPM(FT) 3-2-5
Mr. Marco Césaré, L-3 MAS, PEng*

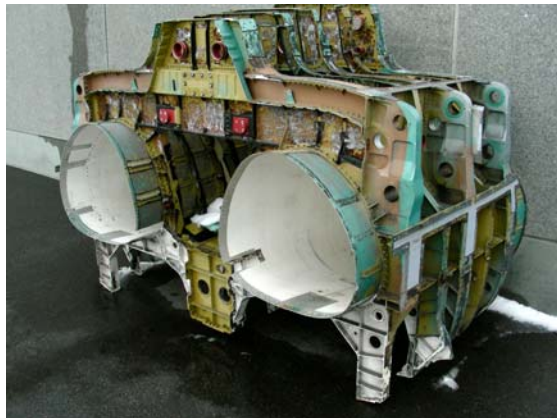
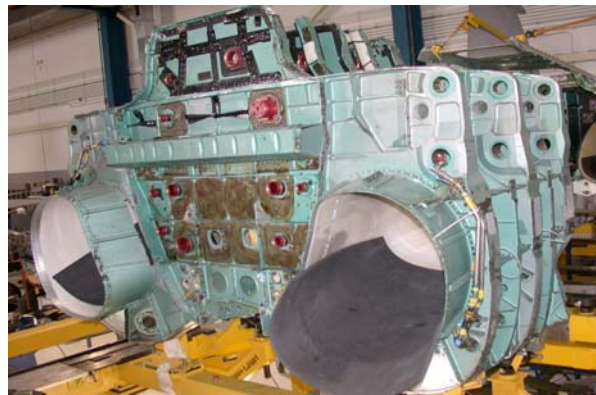
The intrusive nature of this structural modification raised the question of the impact on the existing cable assemblies which are being removed and reinstalled.

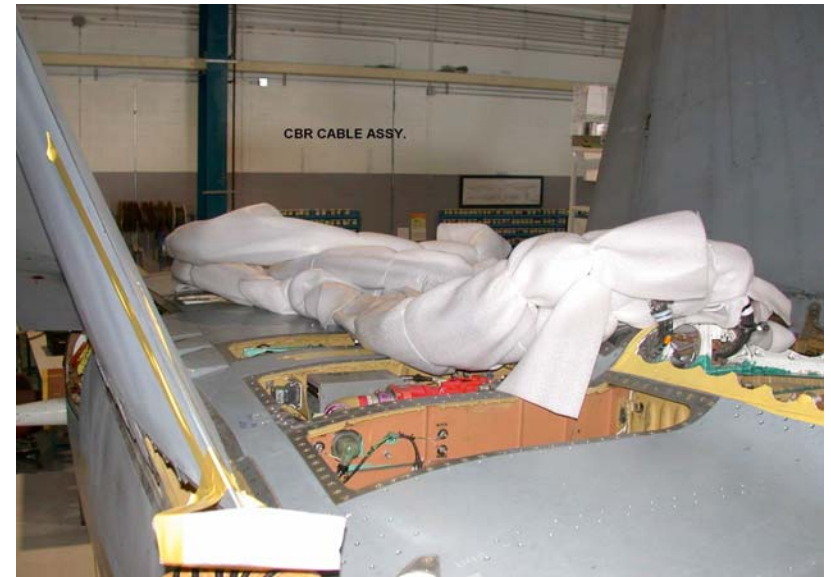
- Cables are being pulled out and/or rolled back
- Splice points are being opened
- Connectors are being disconnected and disassembled
- Potential wear and tear on wire during CBR modification

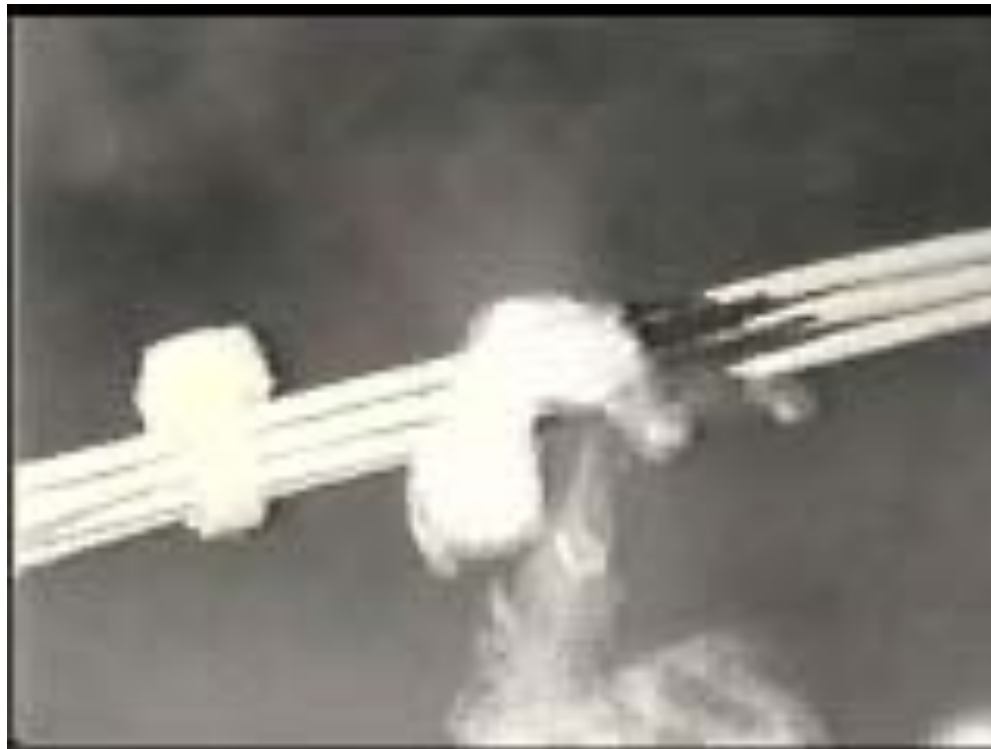
With time, Kapton[®] insulation becomes brittle. Temperature variation, exposure to chemicals, poor maintenance techniques and bad wire handling, can accelerate or worsen the wire condition.

Primary problem with damaged Kapton[®] wiring is arc tracking

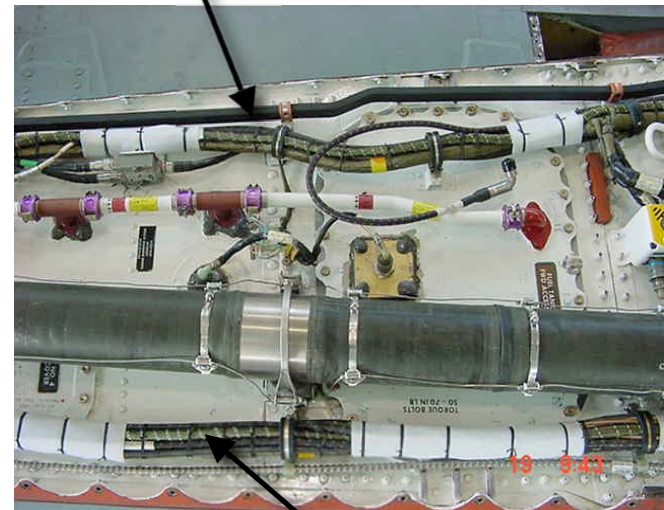
Lectromec's Wire Insulation Deterioration Analysis (WIDAS)

- Total of 107 wire samples taken from different aircraft zones.
- First aircraft (L/H)
 - 29 wires taken before CBR
 - 26 wires taken after CBR
- Second aircraft (R/H)
 - 26 wires taken before CBR
 - 26 wires taken after CBR

Wiring placed in an environment testing chamber capable of accelerated aging under pre-established controlled conditions

Specimen were aged until the insulation fails

Failure criterion was insulation breakdown at a specific voltage

Time until failure compared with baseline determined the percentage of wire insulation life used

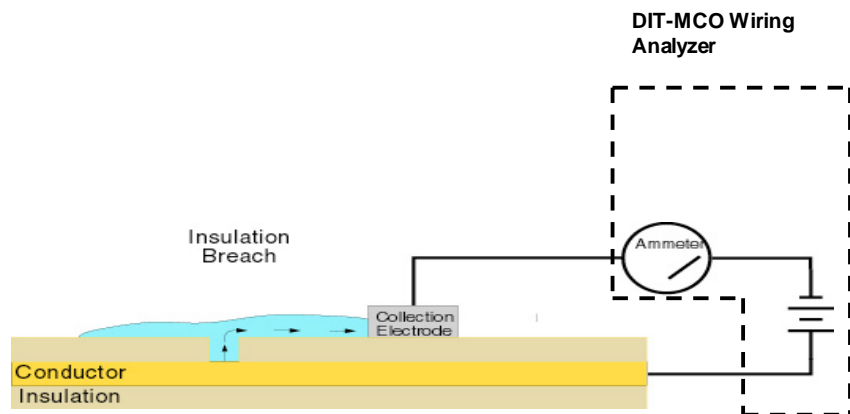
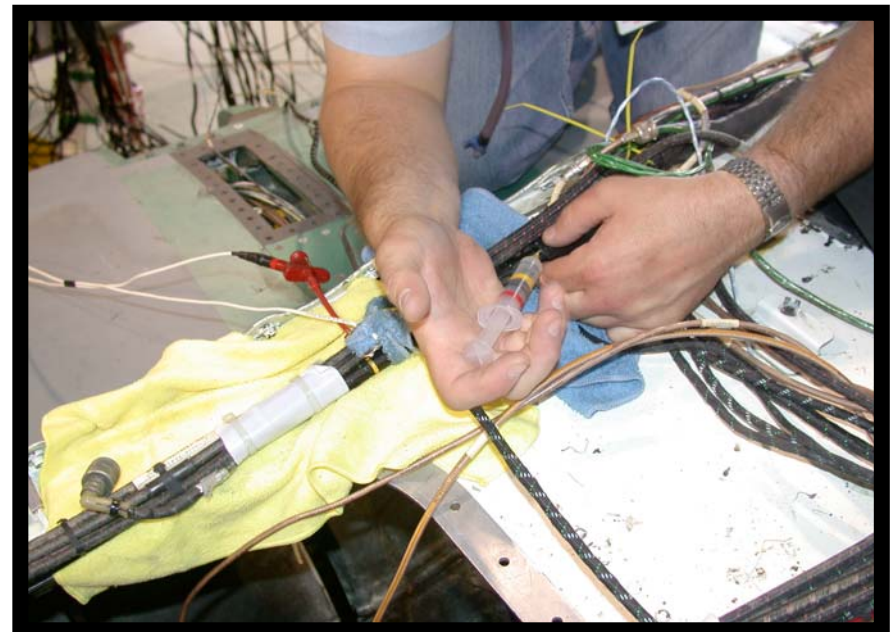
Lectromec's DelTest™

- A conducting fluid applied to a short wire bundle segment.
- A low voltage is applied to the wire.
- A meter measures any electric current leakage into the conductive fluid. If current is evident, there may be a crack in the insulation.

- Breaches in the isolation exist;
 - Location of DelTest™ detected failures observed in close proximity to cable securing clamps
 - Each additional localized breach will increase the risk of system failure and arc tracking

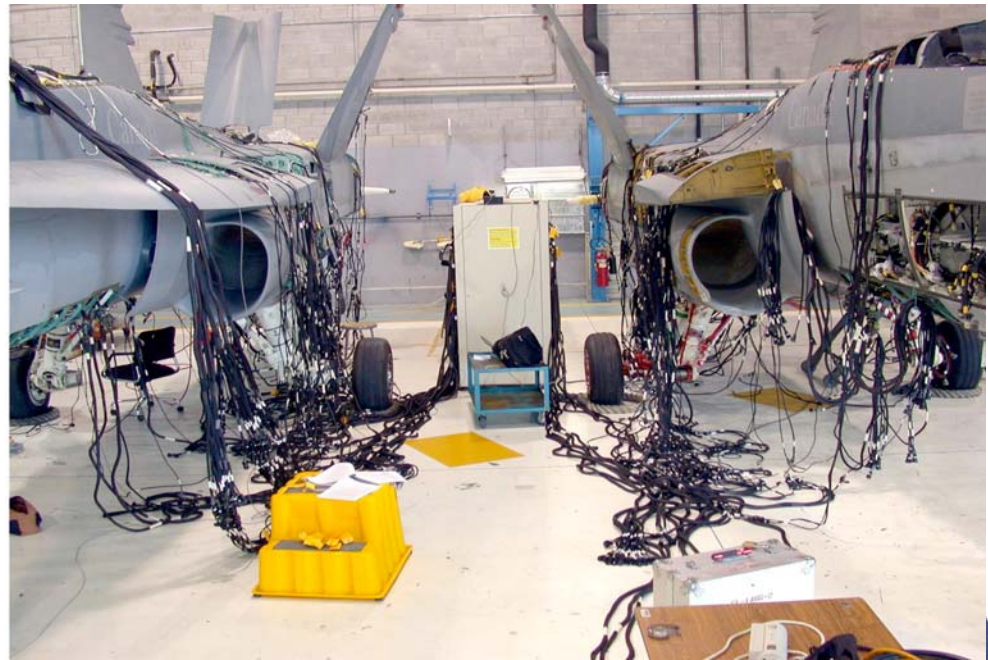
DIT-MCO Electrical Testing

- Isolation, Hi-pot and Continuity Tests performed using DIT-MCO Wire Analyzer model 2500 (GFE).

- First aircraft (L/H)
20 harnesses
- Second aircraft (R/H)
17 harnesses

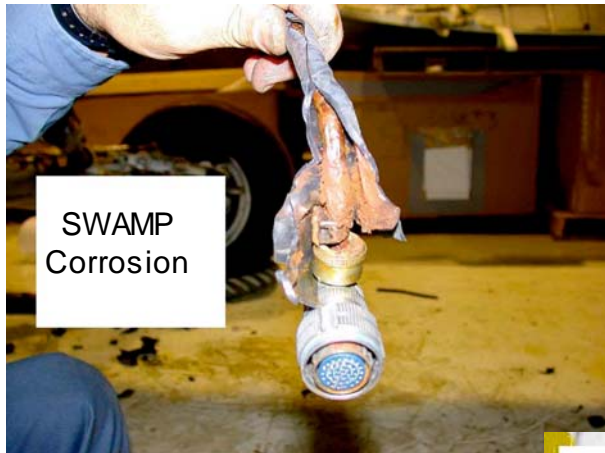
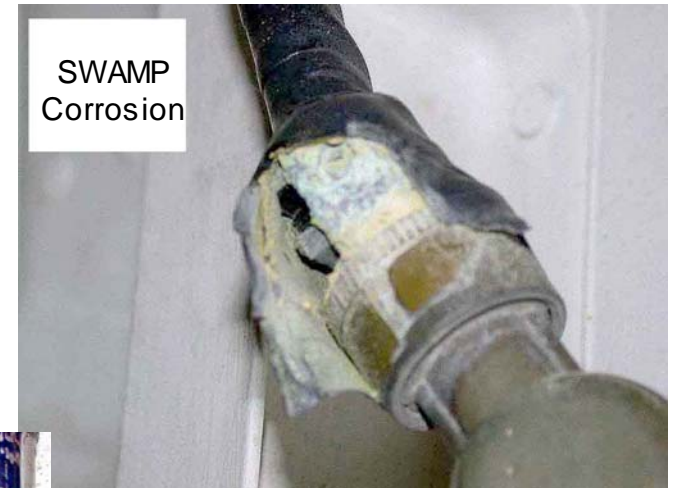
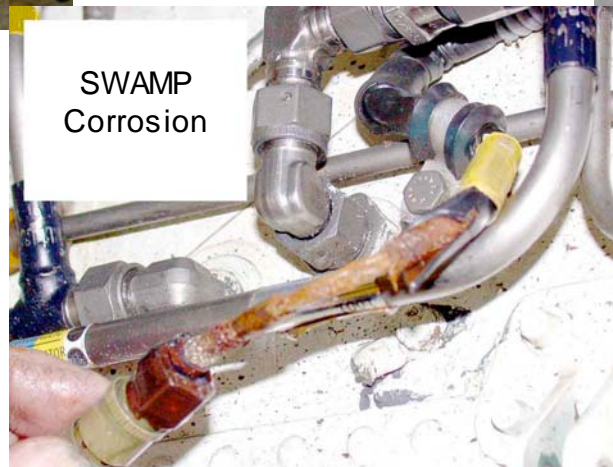
- Evidence of Kapton[®] outer jacket flaking;
- Severe corrosion problems (connectors and wire mesh tape) found in wheel well area;
- Broken connector backshells;

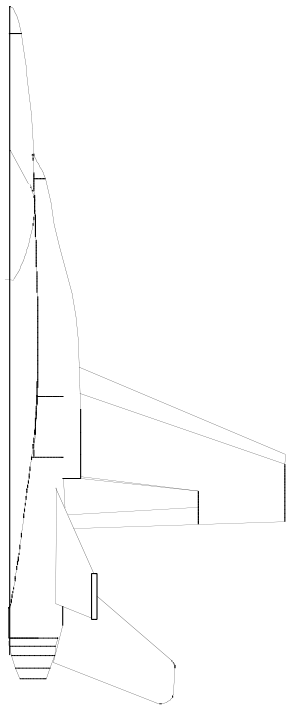
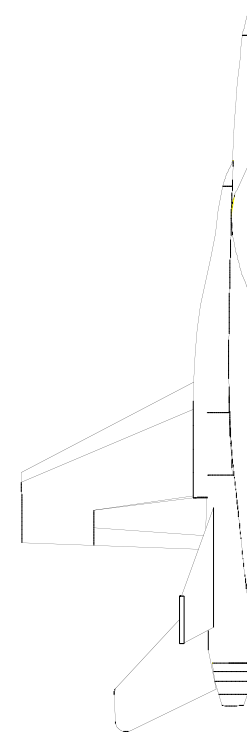
Testing Approach - Summary

Second aircraft R/H

Before CBR

Hi-Potential test
Isolation Test
Continuity Test
DelTest™

CBR Simulation

After CBR

DelTest™
Hi-Potential test
Isolation Test
Continuity Test
Visual inspection

First aircraft L/H

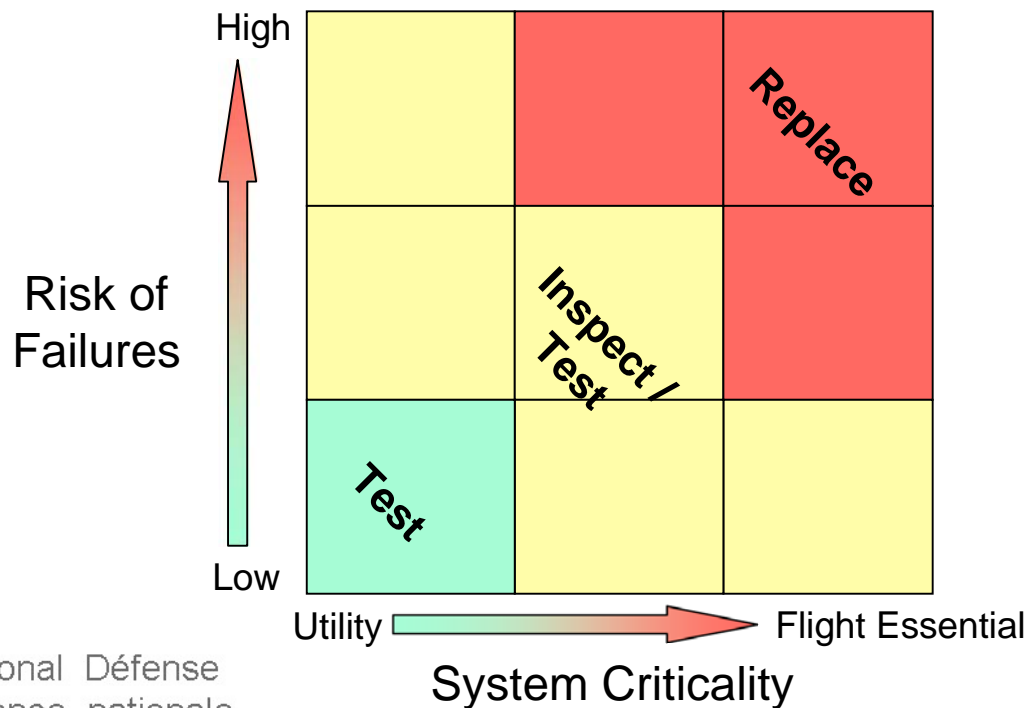
Study sets the base for the risk assessment and a replacement Priority (High, Medium and Low) was assigned to each cable based on system criticality, location and current maintenance data

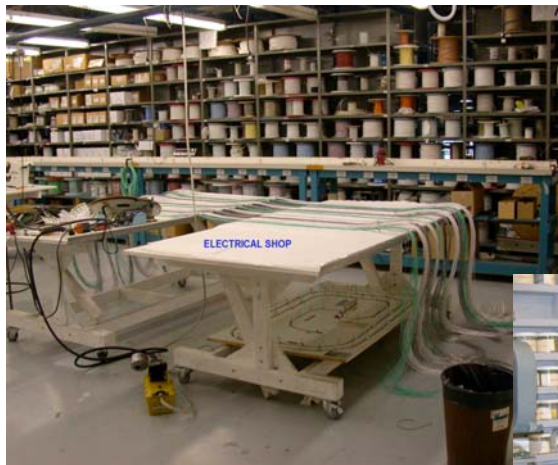
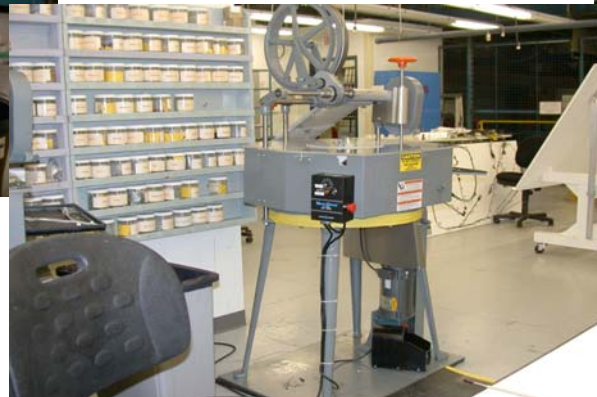
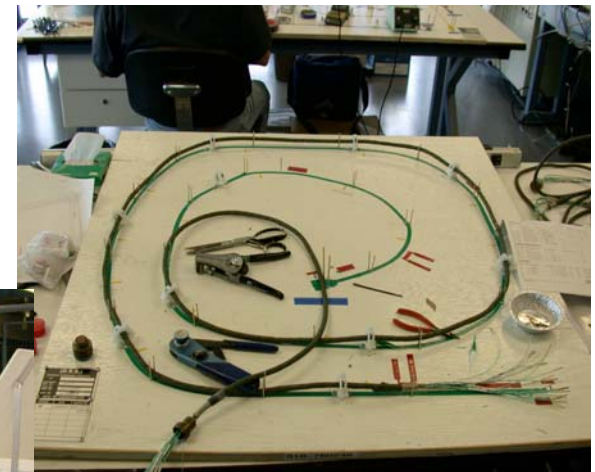
Harness Manufacture:

- Kapton® wire, Silver plated wire, and backshells with drain holes are excluded from new wire harness construction;
- Replacement wire: MIL-W-22759 Composite (seamless)

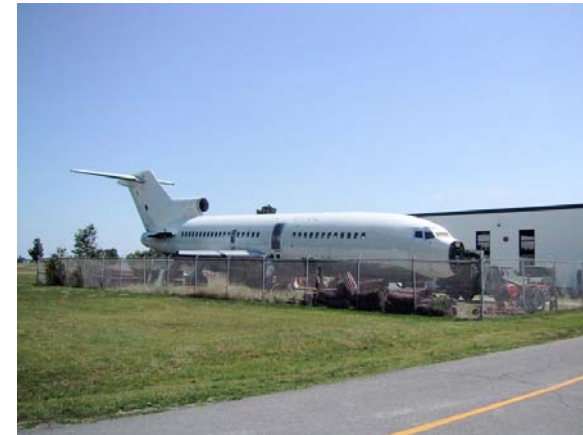
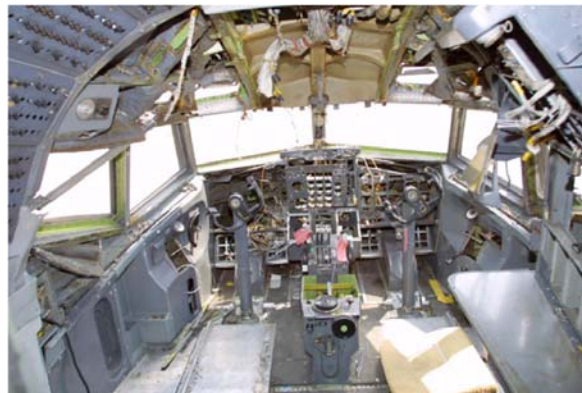
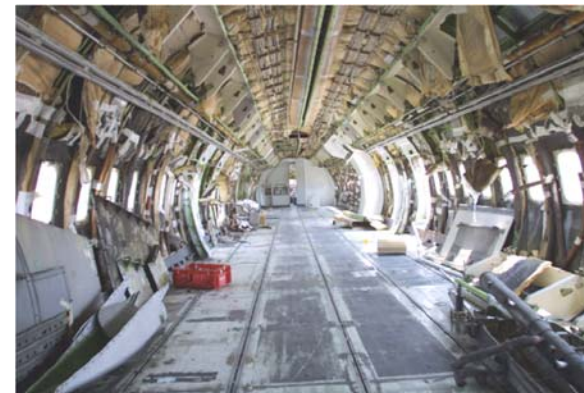
Comprehensive visual inspections
of IAR's 727 testbed airframe

Wiring is mostly intact.

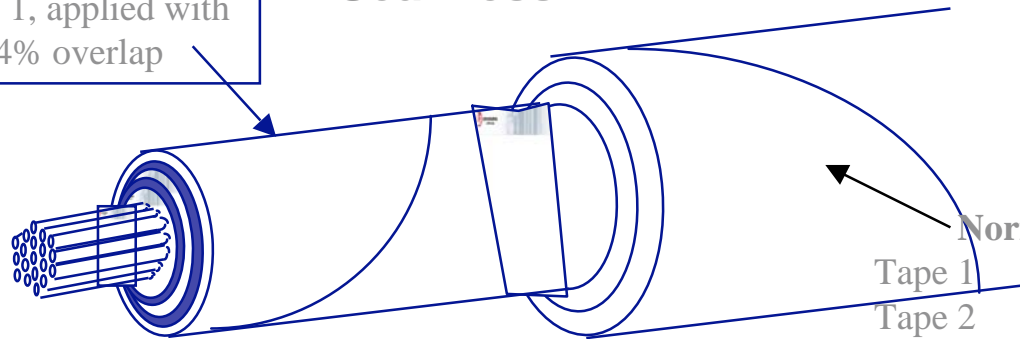
Replacement wire

MIL-W-22759 “Composite” Seamless

Tape 1, applied with
51-54% overlap

Normal Wall Insulation (Airframe)

Tape 1 .5 mil FP / 1 mil PI / .5mil FP
Tape 2 2 mil Unsintered PTFE
Total Nominal Thickness 7.6 mil

Thin Wall Insulation (Hook-Up)

Tape 1 .45 mil FP / .65 mil PI / .1mil FP
Tape 2 2 mil Unsintered PTFE
Total Nominal Thickness 5.8 mil

- Temperature Performance (260C)
- Mechanical Toughness
- Hydrolytic Stability
- Arc Resistance
- Smoke Generation
- Flexibility
- Low Weight
- Laser Markable
